Cigarette Butt Audit Analysis

Blessington Street & St Kilda South Beach

August – November 2011

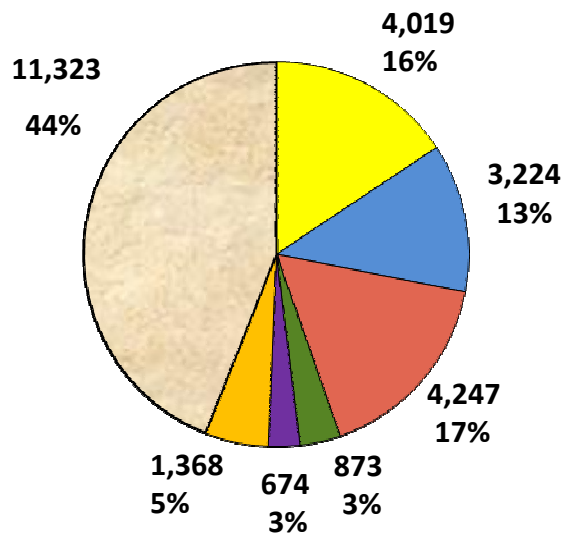
Total Butts Collected

The highest percentage of butts by property type was collected from the beach (44%); more than half in a single survey after heavy rain.

Trader areas recorded the second highest percentages (17% with footpath trading and 13% without footpath trading).

Businesses, including eateries, bars, clothing stores, a laundrette, 2 community centres, a convenience store, and motel comprise around 13% of the total street frontage (footpath trading areas 6% and businesses without footpath trading 7%).

16% of butts were found near residences (40% of total street frontage).

3% of butts were found near parkland (33% of total street frontage).

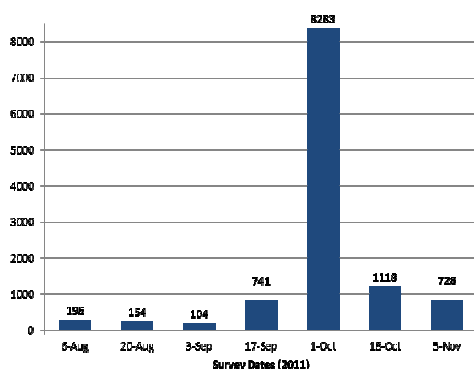
Number of of butts on beach

Butts vs Rainfall: The survey results clearly demonstrate the impact of rainfall on transferring butts from streets to the beach.

Strong correlation between rainfall and butts found on the beach was indicated in the October 1 survey with 8,283 butts on the beach after the highest rainfall week during the survey period (52mm). Coincidentally, the October 1 survey recorded the least butts on the street (29% less than average for the area surveyed).

Existing litter management measures include the Council street cleaning program and footpath traders required to manage litter in their area. Both of these measures lack the flexibility and capacity to respond to impending rainfall.
